1. REPORT NUMBER AFIT - CI-78-112	2. GOVT ACCESSION NO.	3. RECIPIENT'S CATALOG NUMBER 55
4. TITLE (and Subtitle) An Investigation of the Use of Polymer-Concrete for Rapid Repair of Airfield Pavements.	5. TYPE OF REPORT & PERIOD COVERED Thesis

AN INVESTIGATION OF THE USE OF POLYMER-CONCRETE FOR
RAPID REPAIR OF AIRFIELD PAVEMENTS

↙ An investigation was made to determine the feasibility of using polymer-concrete (PC) for rapid repair of airfield pavements. The polymer-concrete studied was a mixture of dry aggregate and a methyl methacrylate monomer. Tests were conducted to isolate the variables that affect the strength and polymerization time of PC. Laboratory and field tests were conducted to test the strength, durability, and feasibility of polymer-concrete repairs.

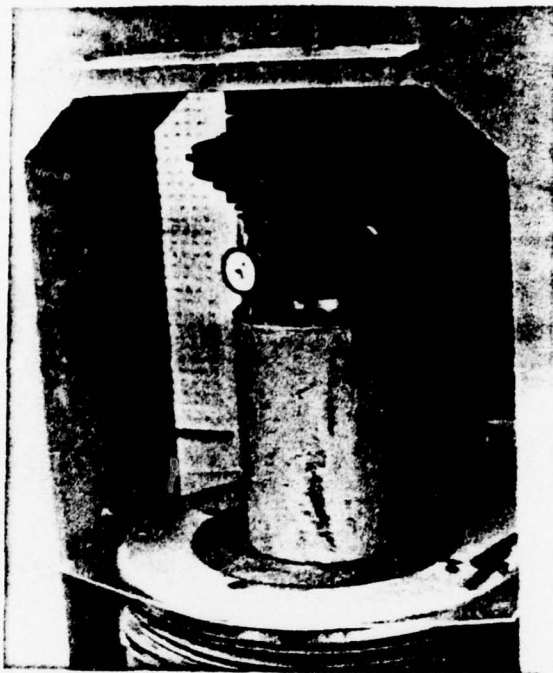
FIGURE 2.1 COMPRESSION STRENGTH AND
MODULUS OF ELASTICITY TESTS

The test for modulus of elasticity was ASTM C469-65: "Static Modulus of Elasticity of Concrete in Compression". This test was the same as the compressive strength test except that a compressometer was fastened to the cylinder to read the compression of the specimen under load (Figure 2.2). The compressometer had two dial gages, on opposite sides of the cylinder, to read the vertical deformations of the specimen in a gage lengths of 4 in. or 10 in. (Figure 2.3). The average gage reading was divided by the gage length to obtain the strain of the specimen in in./in.. The compressive stress was

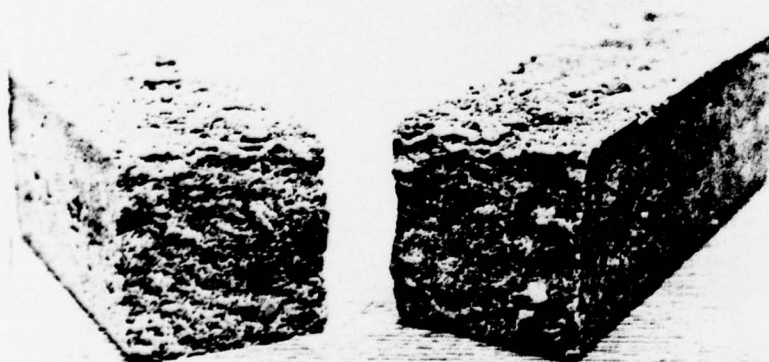
FIGURE 4.6 FAILURE PLANE OF PC BEAM

Just as portland cement concrete depends largely on the strength of the aggregate for the strength and modulus of elasticity so does polymer-concrete. Polymer-concrete can be made from dense, lightweight, and normal aggregates just like portland cement concrete. The stronger the aggregate the stronger the PC. In most cases, the failure plane in PC tends to pass through the large aggregate (Figure 4.4). In tensile tests, it is common to see the failure plane pass through more than half of the large aggregate (Figures 4.5 and 4.6).

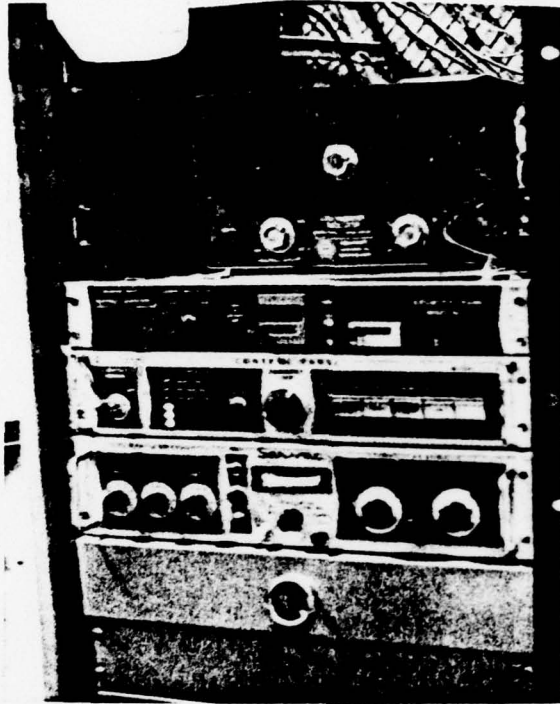
FIGURE 5.5 LVDT RECORDING EQUIPMENT AND
MTS LOAD MACHINE

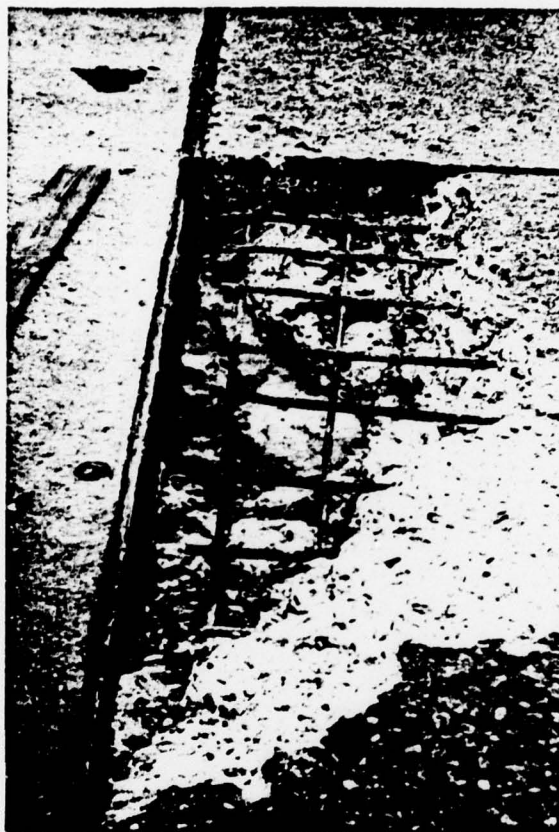
FIGURE 6.3 REPAIR AREA 1 AFTER REMOVAL
OF CONCRETE

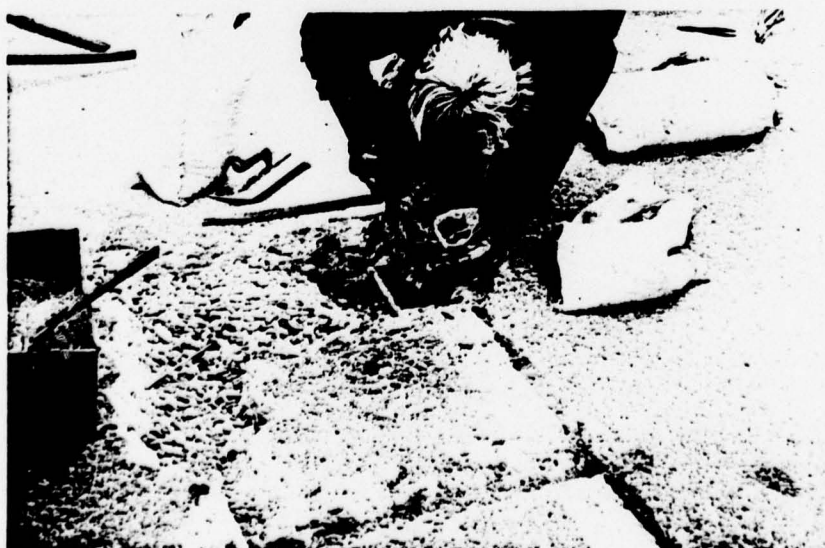
FIGURE 6.4 REPAIR AREA 3 I.H. 35

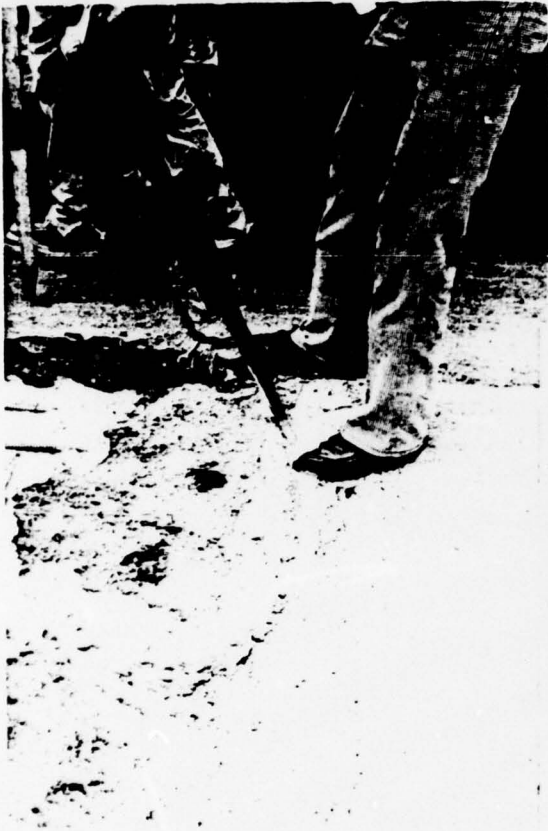
FIGURE 6.7 CONCRETE
PREPARATION

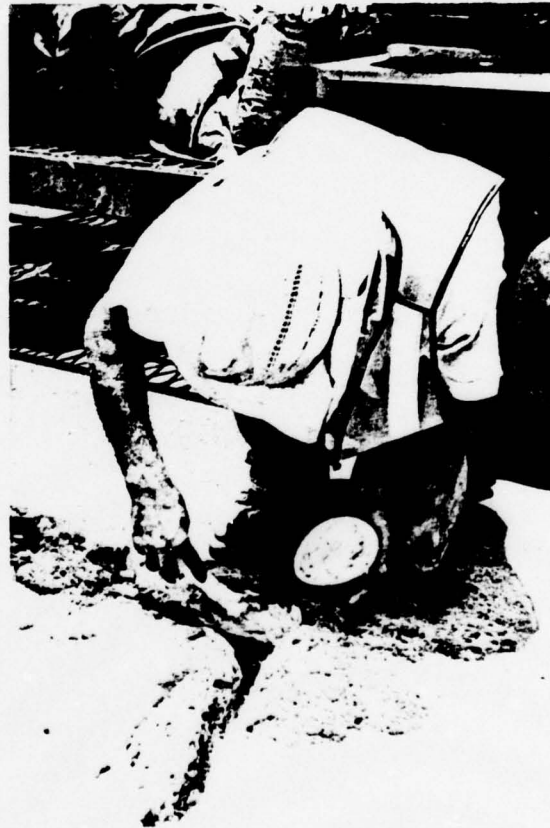
FIGURE 6.8 POLYESTER PUTTY
APPLIED TO
ASPHALT SHOULDER

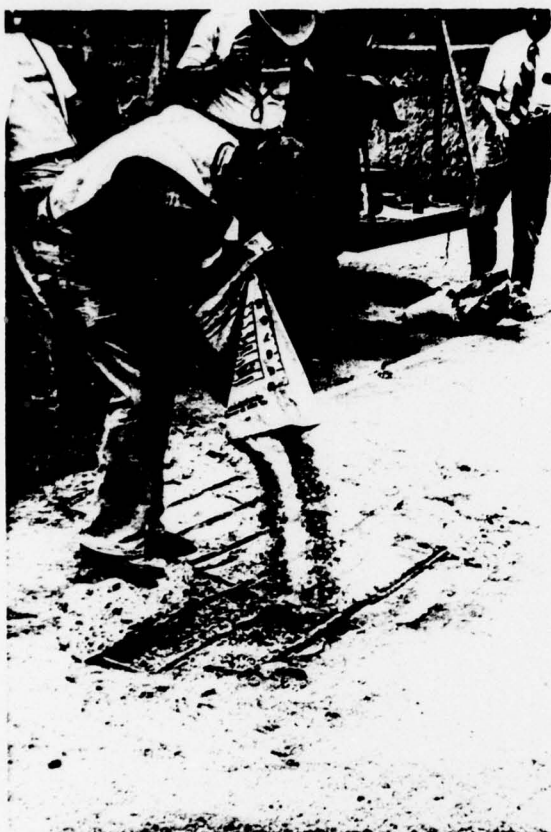
FIGURE 6.9 DRY
AGGREGATE
ADDED TO
AREA 1

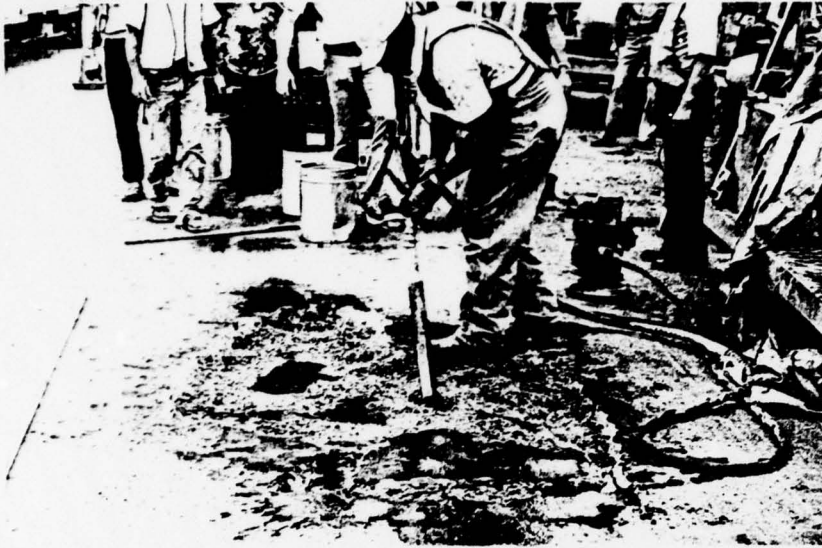
FIGURE 6.11 VIBRATION OF PC: AREA 1

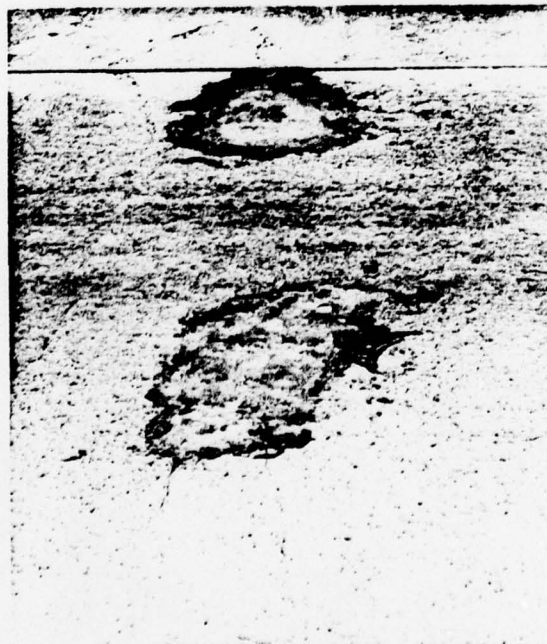
FIGURE 6.14 FINISHED REPAIR OF
AREAS 3 AND 4

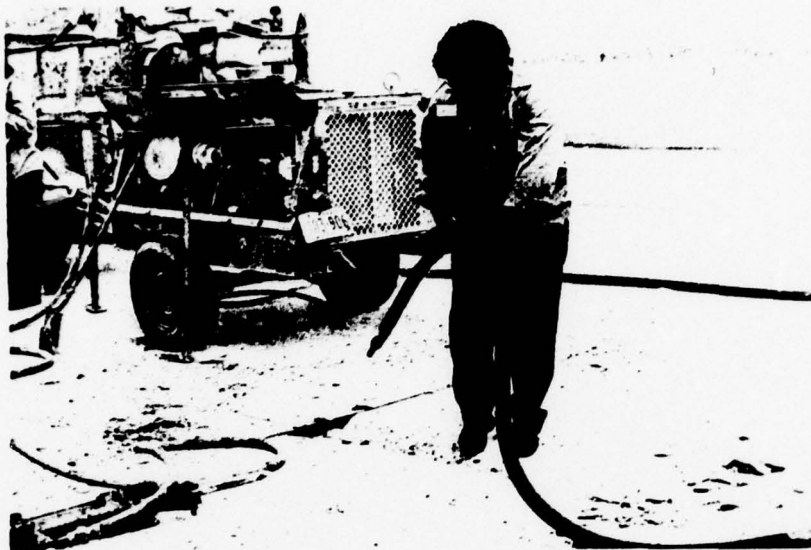
FIGURE 6.18 SANDBLASTING
AREA 1

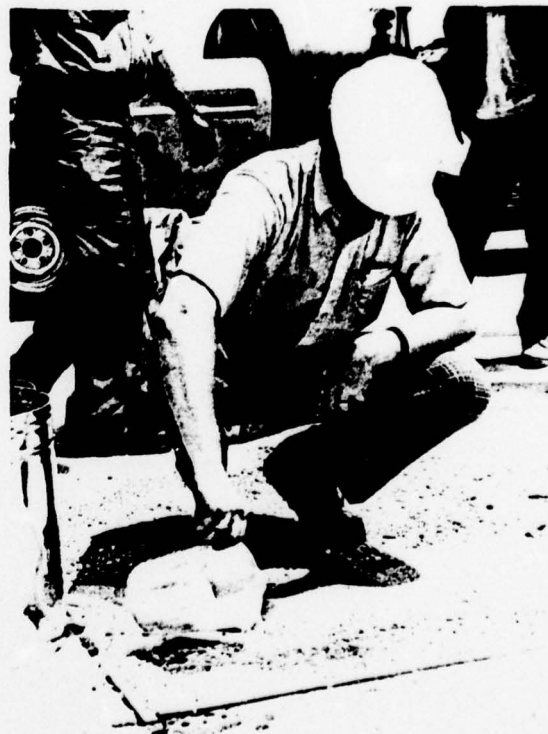
FIGURE 6.19 ADDING MONOMER
TO REPAIR
AREA 1

Area 1. The first repair was located at station 57 + 00 to 57 + 04, 12.5-ft. south of the centerline (Figure 6.15). The repair measured 45-in. by 9-in. with depths varying up to 6-in. and was bounded by two expansion joints (Figure 6.16). A temporary asphalt repair was removed with an air hammer (Figure 6.17) and sandblasting (Figure 6.18). The repair was then cleaned of loose debris with compressed air. The removal of all asphalt was deemed necessary because asphalt tends to retard the curing of the monomer system. Wood strips were fitted along the two edges to maintain the expansion joints. An approximate 50:50 mixture by weight of oven-dried 3/8-in. topping rock and sandblasting sand was placed in the repair and leveled to grade. The monomer system (Table 6.3) was added until the aggregate was saturated (Figure 6.19). The

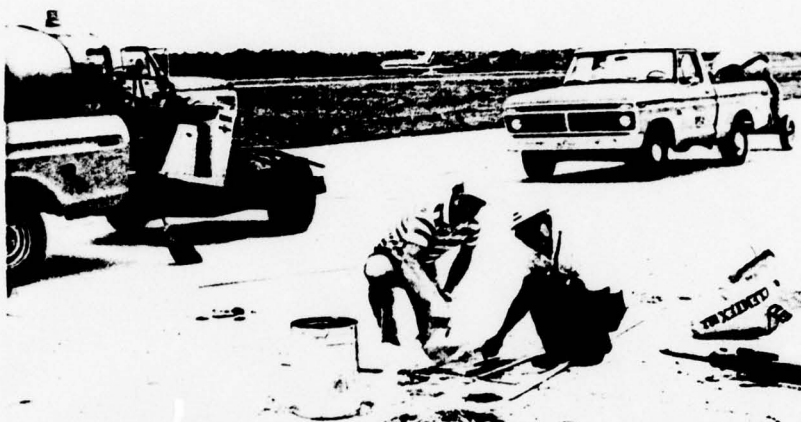
FIGURE 6.20 TROWELING AREA 1

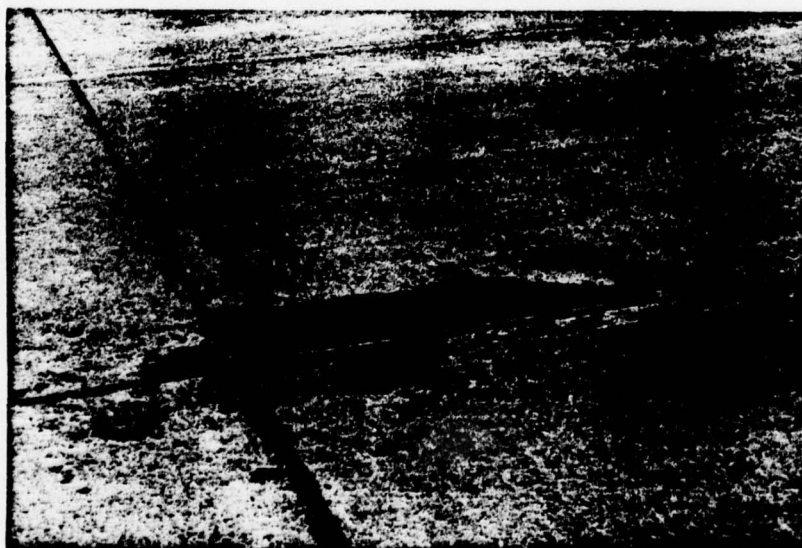
FIGURE 6.21 COMPLETED REPAIR OF AREA 1

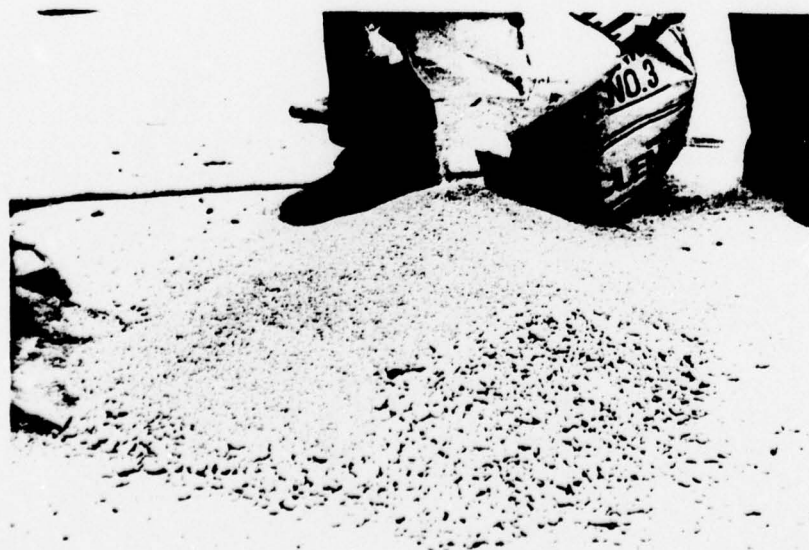
FIGURE 6.23 MIXING OF SAND AND 3/8-IN. TOPPING ROCK

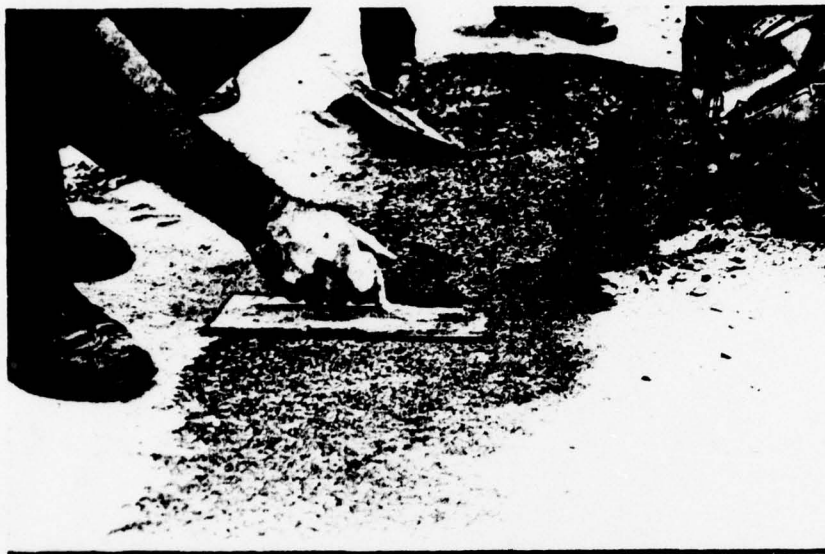
FIGURE 6.24 TROWELING AREA 2

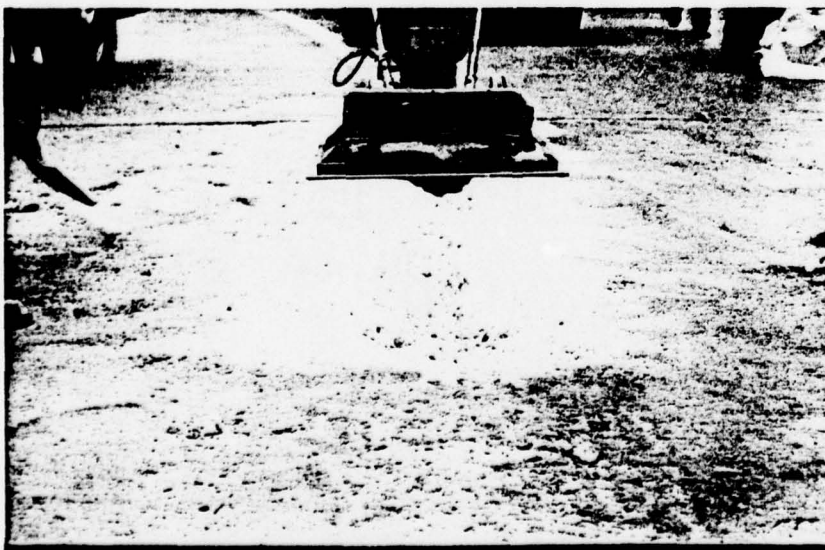
FIGURE 6.25 DRYING CONCRETE OF AREA 3

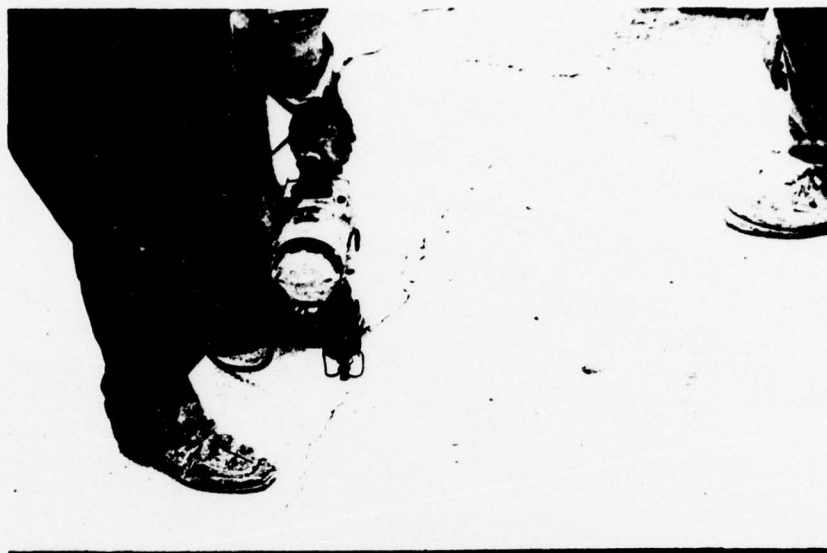
FIGURE 6.26 DRILLING HOLES ALONG CRACK IN AREA 4

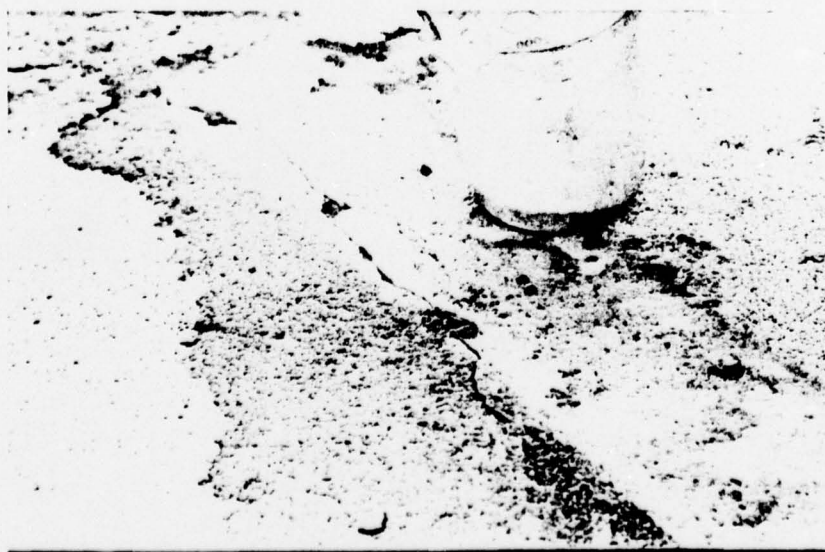
FIGURE 6.27 SATURATING AREA 4 WITH MONOMER

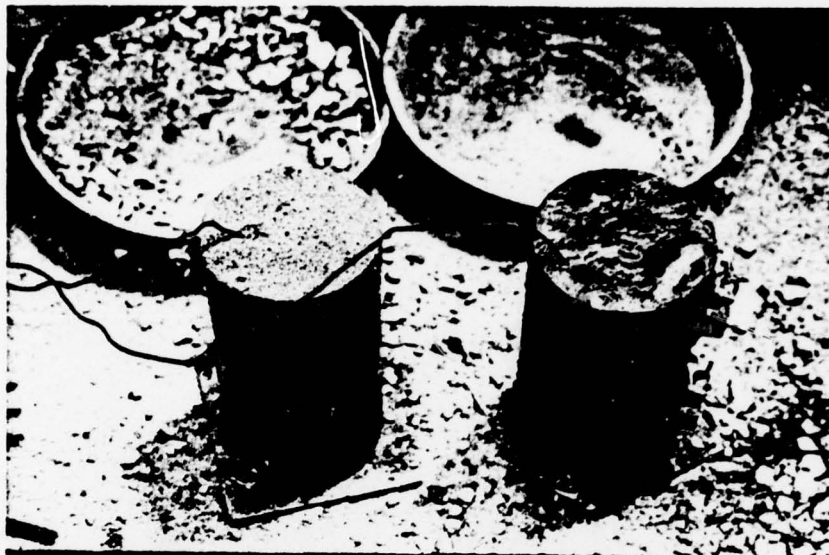
FIGURE 7.1 TEST CYLINDERS WITH TMPTMA (LEFT)
AND WITHOUT TMPTMA (RIGHT)

Blistering was a phenomenon observed in the field tests of PC at high ambient temperatures. This was a potentially significant problem for airfield pavements because of the possibility of pieces of PC flaking off and being ingested into jet engines. A test was conducted to duplicate the conditions of the field tests and then to attempt to eliminate the blistering. The test was conducted at an ambient temperature of 100°F and the monomer was set in the sun to warm. Specimens were cast using 6-in. by 12-in. cylinders, one with the field test formulation and one with an identical formulation except the addition of 5% TMPTMA, a cross-linking agent. The experiment showed that blistering can be controlled with the addition
